### INFRARED THERMOGRAPHY REPORT

Date	4 September 2012	Equipment	Cap.bank 1
From	PT. Rickstar Indonesia	Location equipment	
Client		Object	Mccb 125 A
Project		Image number	1
Project Location		Checked

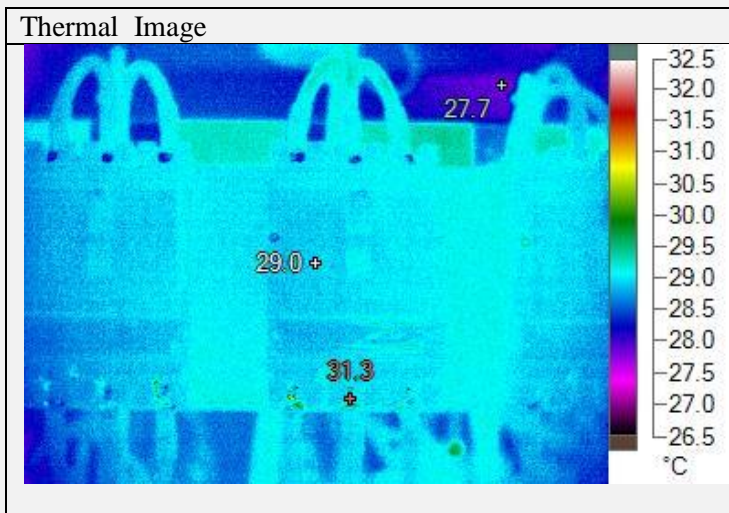
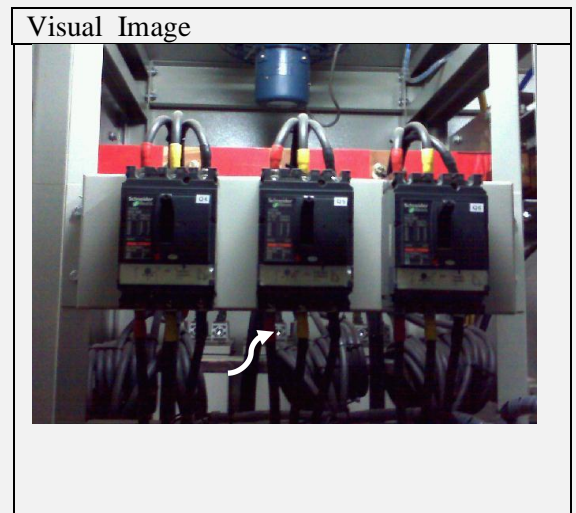
Temperature Data (C°)	
Maximum Temperature On Spot	31,6
Reference Temperature	60
Temperature rise ( $\delta$ )	-
Clasification Code	A

Probable Cause and Comments	
Temperature normal.

RECOMMENDATION	
Lakukan Perawatan Berkala Tiap Tahun.

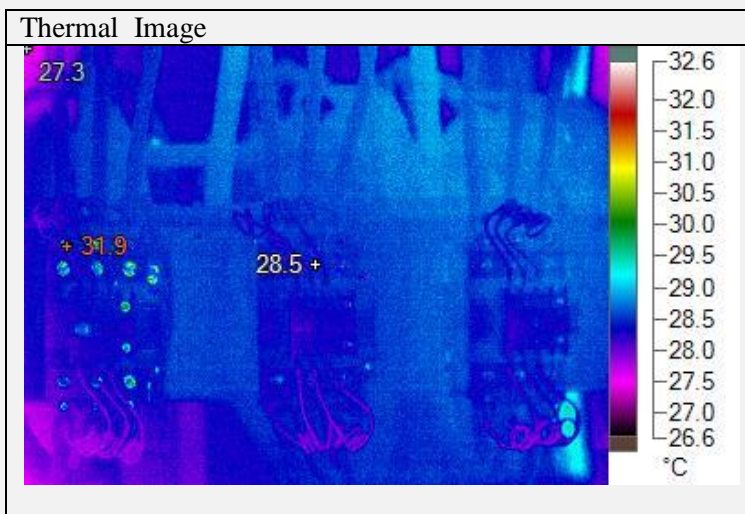
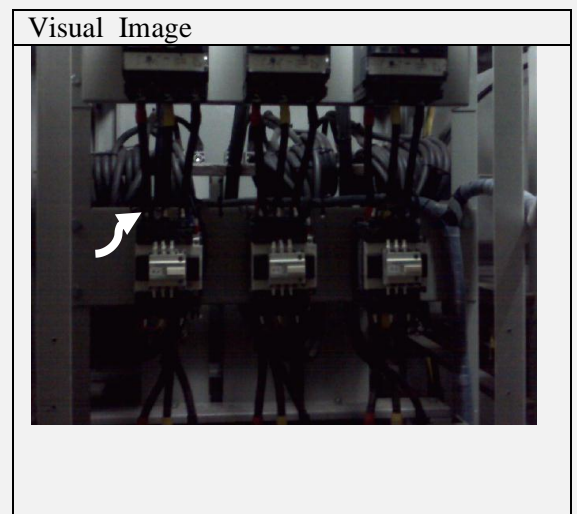
Date	4 September 2012	Equipment	Cap.bank 1
From	PT. Rickstar Indonesia	Location equipment	
Client		Object	Contactora LCI-DWK12
Project		Image number	2
Project Location		Checked

Maximum Temperature On Spot	31,5
Reference Temperature	60
Temperature rise ( $\delta$ )	-
Classification Code	A

Temperature normal.

Lakukan Perawatan Berkala Tiap Tahun.

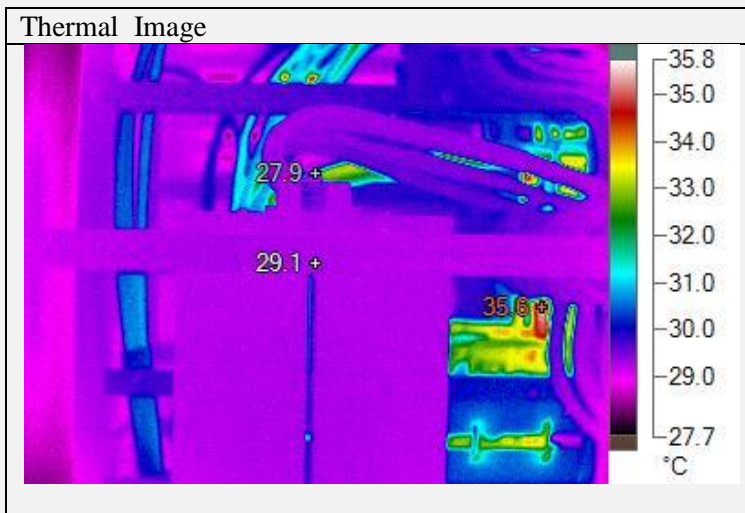
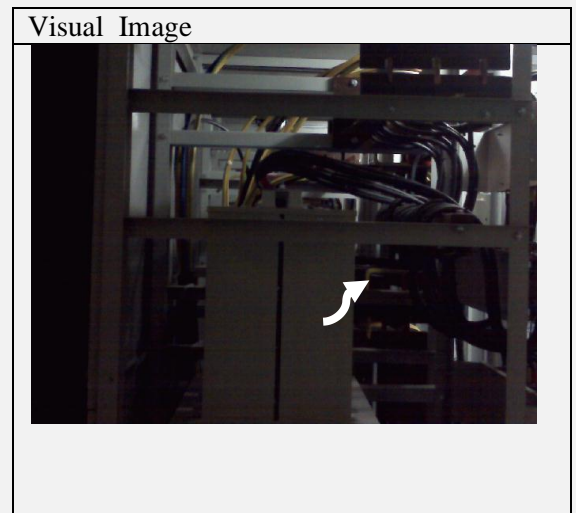
Date	4 September 2012	Equipment	Cap.bank 1
From	PT. Rickstar Indonesia	Location equipment	
Client		Object	Capasitor
Project		Image number	3
Project Location		Checked

Temperature Data (C°)	
Maximum Temperature On Spot	35,6
Reference Temperature	60
Temperature rise ( $\delta$ )	-
Clasification Code	A

Probable Cause and Comments	
Temperature normal.	
RECOMMENDATION	
Lakukan Perawatan Berkala Tiap Tahun.	
FOLLOW UP BY MAINTENANCE STAFF	
Date	
Comment	
Sign By

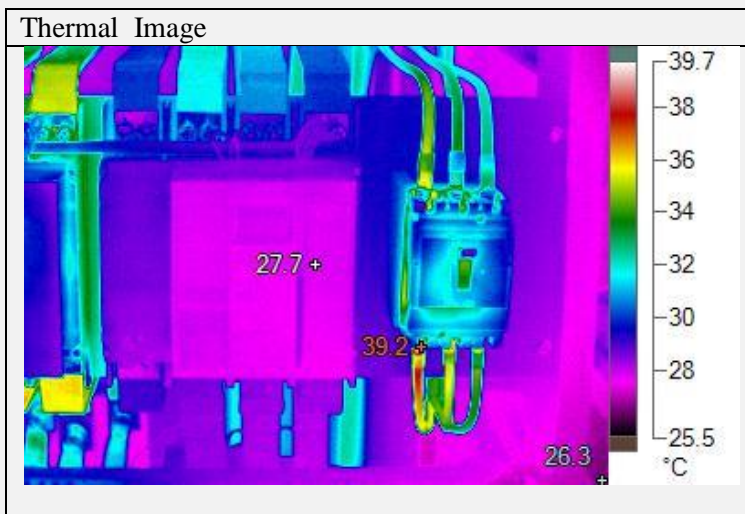
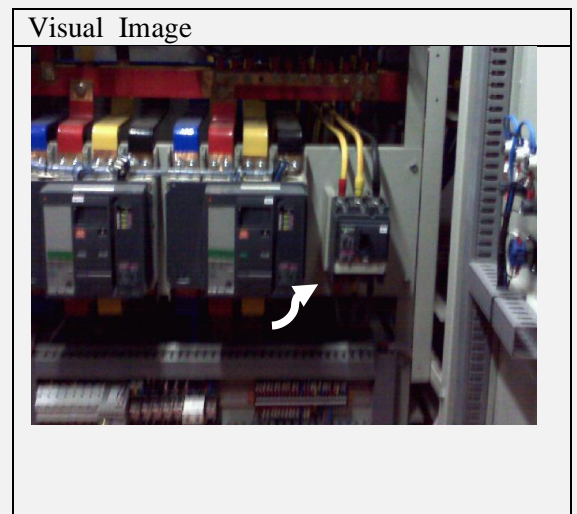
Date	4 September 2012	Equipment	LVDP 1
From	PT. Rickstar Indonesia	Location equipment	
Client		Object	Mccb 100A
Project		Image number	4
Project Location		Checked

Temperature Data (C°)	
Maximum Temperature On Spot	39,2
Reference Temperature	60
Temperature rise ( $\delta$ )	-
Clasification Code	A

Probable Cause and Comments
Temperature Normal.

RECOMMENDATION
Lakukan Perawatan Berkala Tiap Tahun.

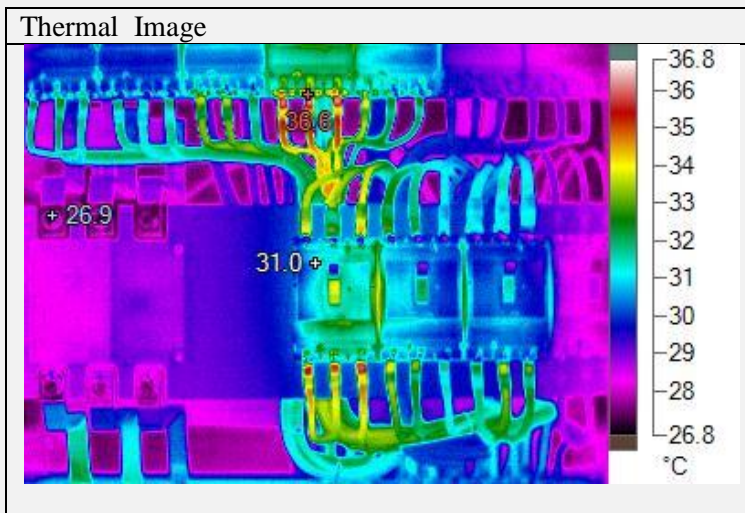
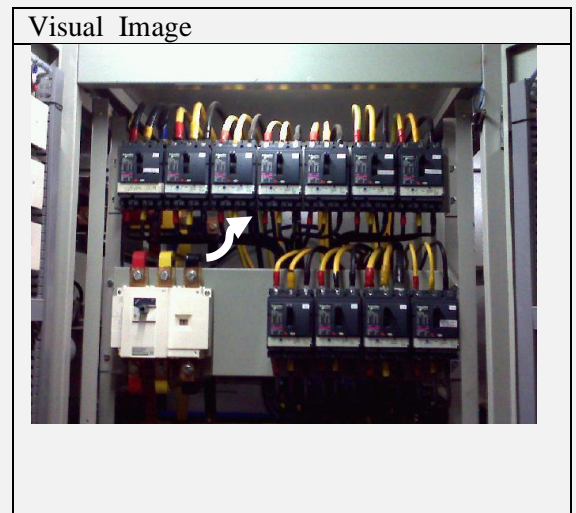
Date	4 September 2012	Equipment	LVDP 1
From	PT. Rickstar Indonesia	Location equipment	
Client		Object	Out Going Mccb 3p (Q2-Q12)
Project		Image number	5
Project Location		Checked

Temperature Data (C°)	
Maximum Temperature On Spot	36,7
Reference Temperature	60
Temperature rise ( $\delta$ )	-
Clasification Code	A

Probable Cause and Comments	
Temperature normal	
RECOMMENDATION	
Lakukan berkala tiap tahun	
FOLLOW UP BY MAINTENANCE STAFF	
Date	
Comment	
Sign By

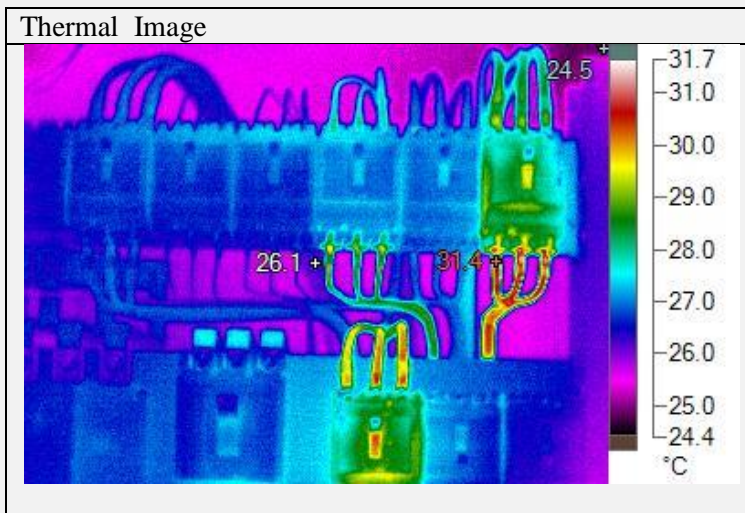
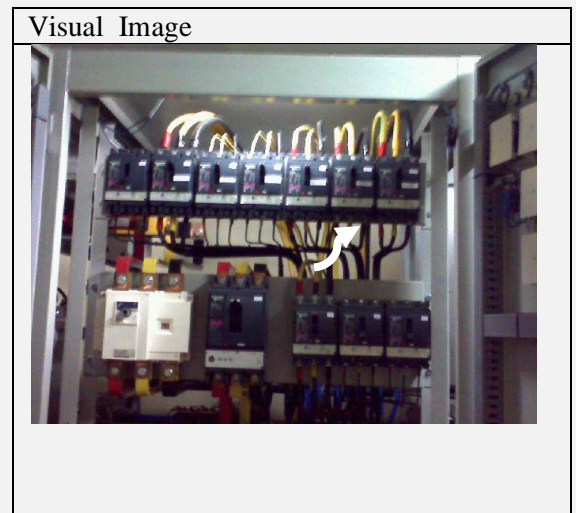
Date	4 September 2012	Equipment	SDP
From	PT. Rickstar Indonesia	Location equipment	
Client		Object	Out going (Q0,Q2-Q12)
Project		Image number	6
Project Location		Checked

Temperature Data (C°)	
Maximum Temperature On Spot	31,4
Reference Temperature	60
Temperature rise ( $\delta$ )	-
Clasification Code	A

Probable Cause and Comments	
Temperatur Normal.	
RECOMMENDATION	
Lakukan Perawatan Berkala Tiap Tahun.	
FOLLOW UP BY MAINTENANCE STAFF	
Date	
Comment	
Sign By

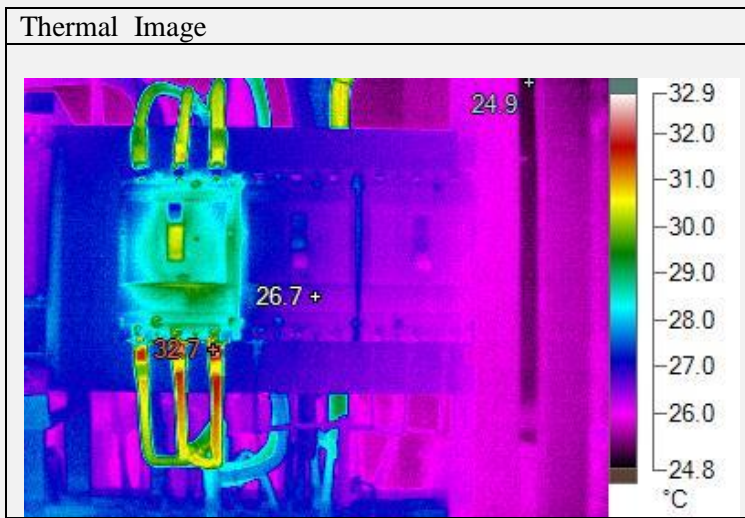
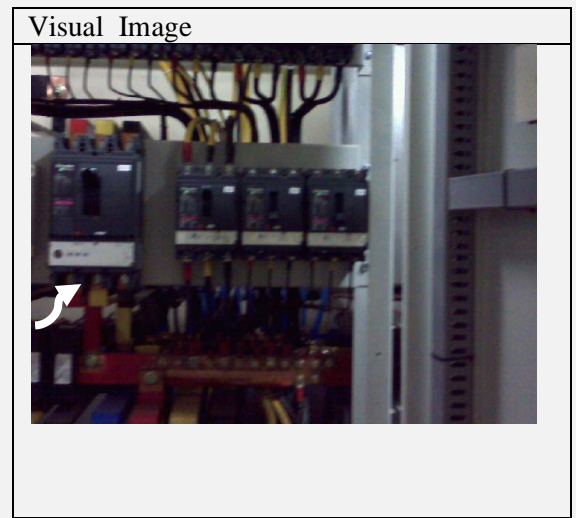
Date	4 September 2012	Equipment	SDP
From	PT. Rickstar Indonesia	Location equipment	
Client		Object	Out Going (Q4.6-Q4.16)
Project		Image number	7
Project Location		Checked

Temperature Data (C°)	
Maximum Temperature On Spot	32,7
Reference Temperature	60
Temperature rise ( $\delta$ )	-
Clasification Code	A

Probable Cause and Comments	
Temperatur Normal.

RECOMMENDATION	
Lakukan Perawatan Berkala Tiap Tahun.

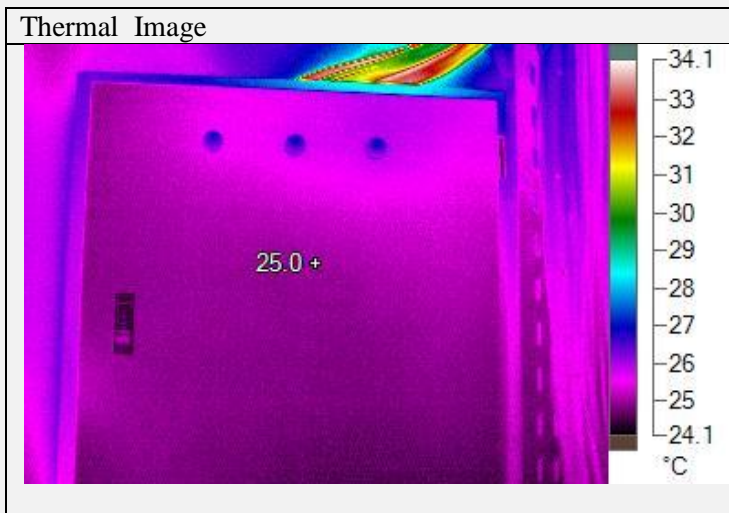
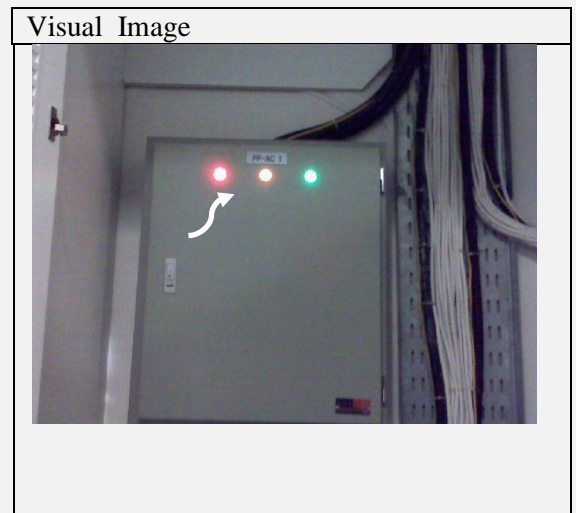
Date	4 September 2012	Equipment	PP-AC 1
From	PT. Rickstar Indonesia	Location equipment	
Client		Object	Indicator Pilot Lamp
Project		Image number	8
Project Location		Checked

Temperature Data (C°)	
Maximum Temperature On Spot	26,3
Reference Temperature	60
Temperature rise ( $\delta$ )	-
Clasification Code	A

Probable Cause and Comments	
Temperature Normal	
RECOMMENDATION	
Lakukan Perawatan Berkala Tiap Tahun.	
FOLLOW UP BY MAINTENANCE STAFF	
Date	
Comment	
Sign By

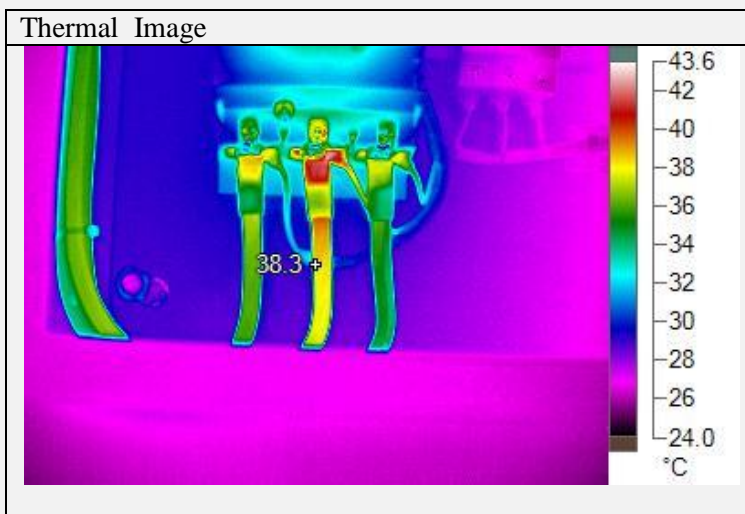
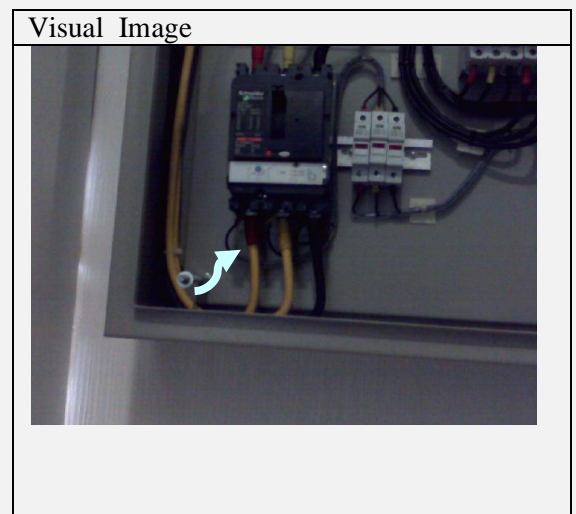
Date	4 September 2012	Equipment	PP-AC 1
From	PT. Rickstar Indonesia	Location equipment	
Client		Object	Mccb Q0
Project		Image number	9
Project Location		Checked

Maximum Temperature On Spot	43,2
Reference Temperature	60
Temperature rise ( $\delta$ )	-
Classification Code	<b>B</b>

Temperature Normal

Lakukan Perawatan Berkala Tiap Tahun.

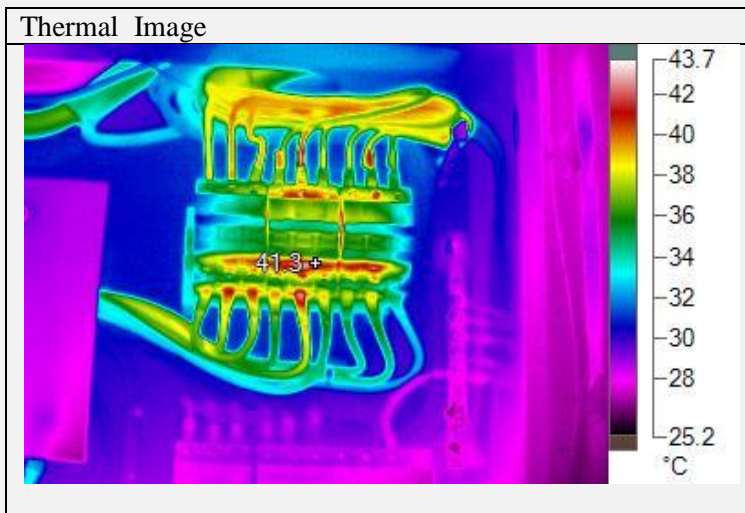
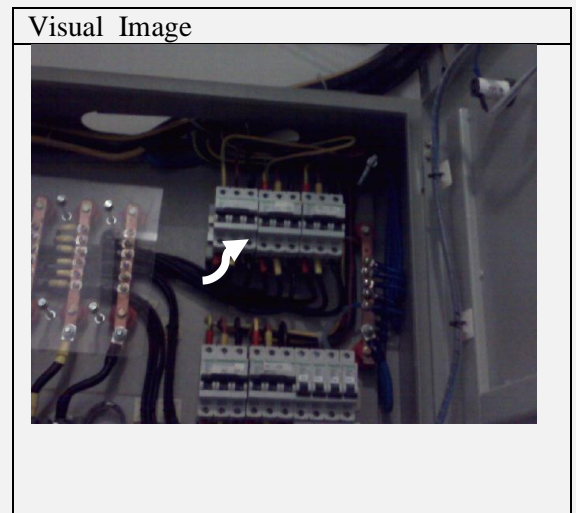
Date	4 September 2012	Equipment	PP-AC 1
From	PT. Rickstar Indonesia	Location equipment	
Client		Object	Outgoing Q1-Q3
Project		Image number	10
Project Location		Checked

Temperature Data (C°)	
Maximum Temperature On Spot	34,2
Reference Temperature	60
Temperature rise ( $\delta$ )	-
Clasification Code	A

Probable Cause and Comments	
Temperature Normal	
RECOMMENDATION	
Lakukan Perawatan Berkala Tiap Tahun.	
FOLLOW UP BY MAINTENANCE STAFF	
Date	
Comment	
Sign By
